# Manhole Inspection Summary

Manhole # S65G\_\_002MH

Insp Date: **3/14/08 11:23 AM**

**Location** Address: **400 Folcroft St.**

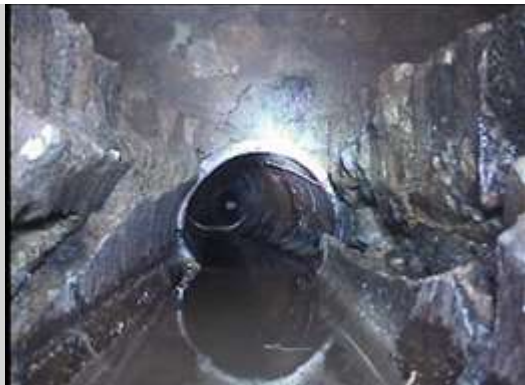
6 O'Clock Inflow

Pipe Height: **8.4** (in.) Rod and Bar (Angled)  
Pipe Material: **Clay** ☐ Pipe Lined  
Invert Depth: **8.58** (ft.) Flow Characteristics: **Slow**  
Deposits: ☒ None ☐ Mud ☐ Sludge ☐ Debris ☐ Grease  
Silt Depth: (in.) Deposits Extent:  
Infiltration: **None** Pipe Seal Cond: **Sound**
